Structural Analysis of DEW Line Station DYE-2, Greenland 1983-1988

Michael R. Walsh and Herbert T. Ueda

June 1998

CRREL Report 98-3

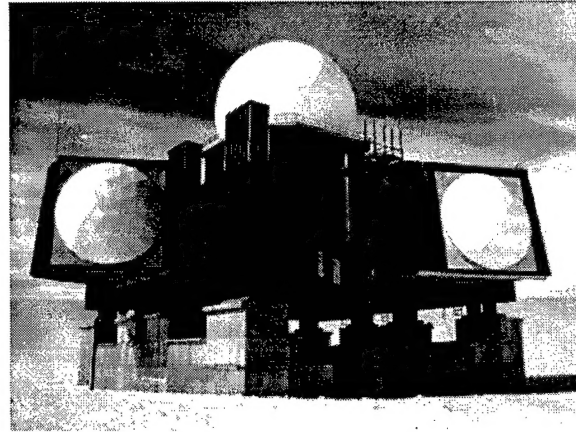
Figure 3. DYE-2: 1977.

During the intervening years, the column foundations had been distorted by differential settlement due to the nature of the supporting snow. The foundation distortions caused secondary stresses to accumulate in the structural frame. In addition, hydrostatic pressure from the surrounding snow became higher as the building was raised and the column length below the snow surface increased. Eventually, the pressure was high enough to begin distorting and crushing the protective wooden enclosures, shown beneath the building in Figure 3.

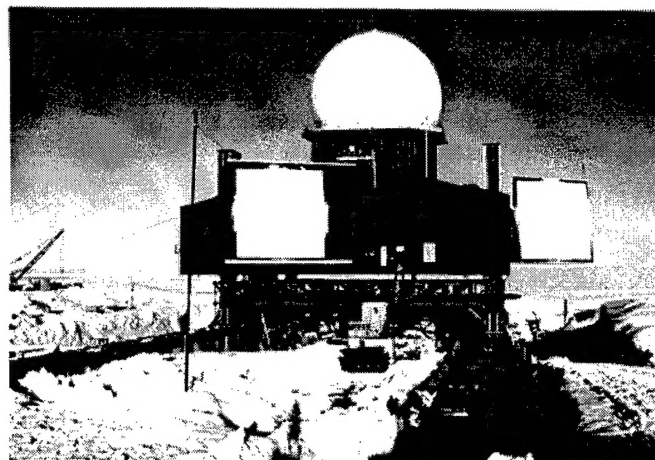
Figure 4. DYE-2 move: 1982.

By the early 1980s, measurements indicated that column stresses were sufficiently high to require drastic remedial action. In 1982, the supporting structure was severed at a new base level, and DYE-2 was moved sideways 64 m onto a new set of footings (Fig. 4). The following year, the building was lifted 8.2 m. Since that time, CRREL personnel monitored building and col-

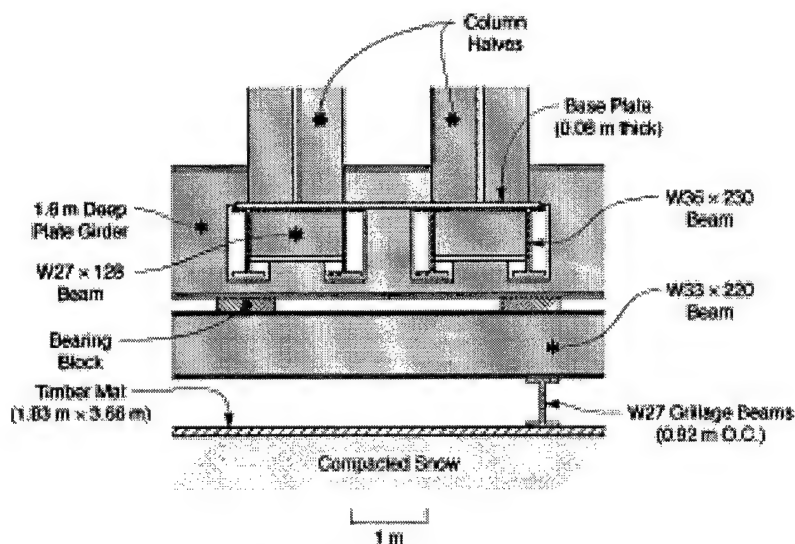
Figure 9. Column footings.

Differential settlement of the column footings is caused by differences in densification rates of the foundation snow beneath each column footing. At DYE-2, the snow was not of uniform consistency because of the presence of ice lenses of various sizes and thicknesses imbedded in the matrix of the snow. These "defects" were formed by snow melting and refreezing during the warm summer months and subsequent burial beneath drifted or fallen snow. Matrix density irregularities cause differences in the densification rate for a given load, and thus settlement irregu-

larities can occur beneath different columns. A column that settles more rapidly on its snow foundation will not support as much load as the adjoining columns, which then must assume a portion of the sunken column's load. Continued settlement will result in structural tilting and a redistribution of stresses. This results in increased stresses in the structure because of uneven loading and tilting.

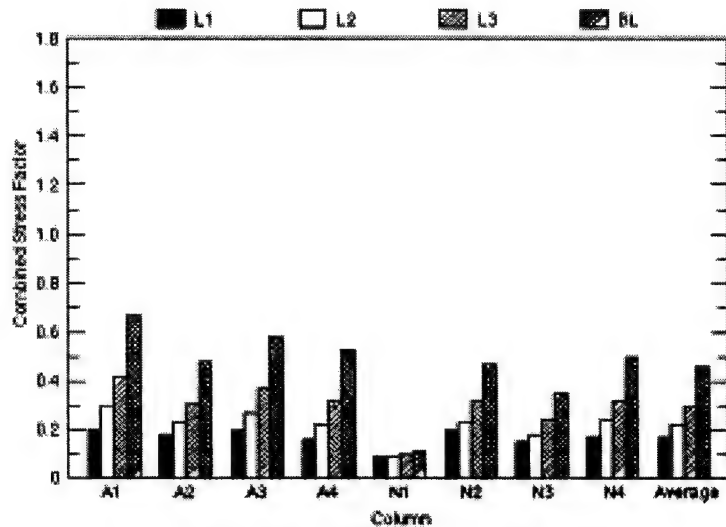
Figure B1. Swaybolt loads: 1983.

Figure B1 contains sway bolt data for the building level only. At the time readings were taken, work was not complete on the 1983 lift operation. Stress factors for other levels are extrapolations from the building level stresses.
